FRP PANEL “TORTURE” TEST

GLASBORD® Wall Panels with Surfaseal® Finish

FORM 6342

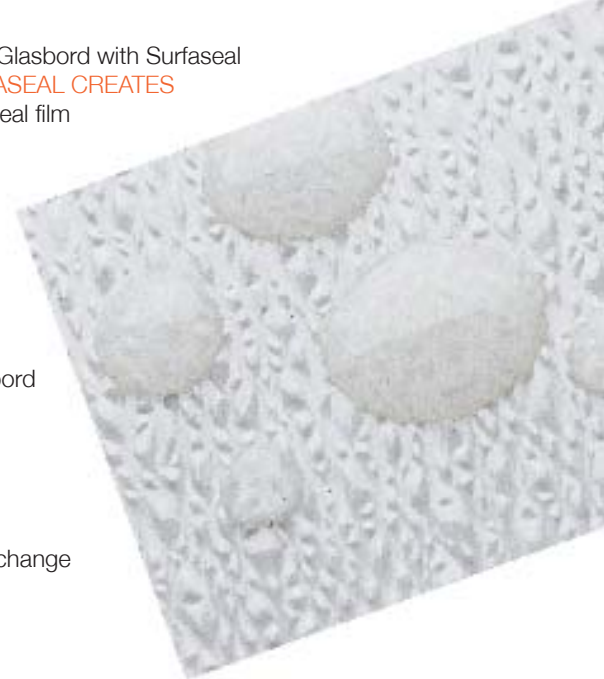
- Evaluate samples with Video Imaging Microscope.
- Observe the abraded areas for actual surface damage.
- Compare the amount of stain that remained on the surface of various panels after being cleaned.

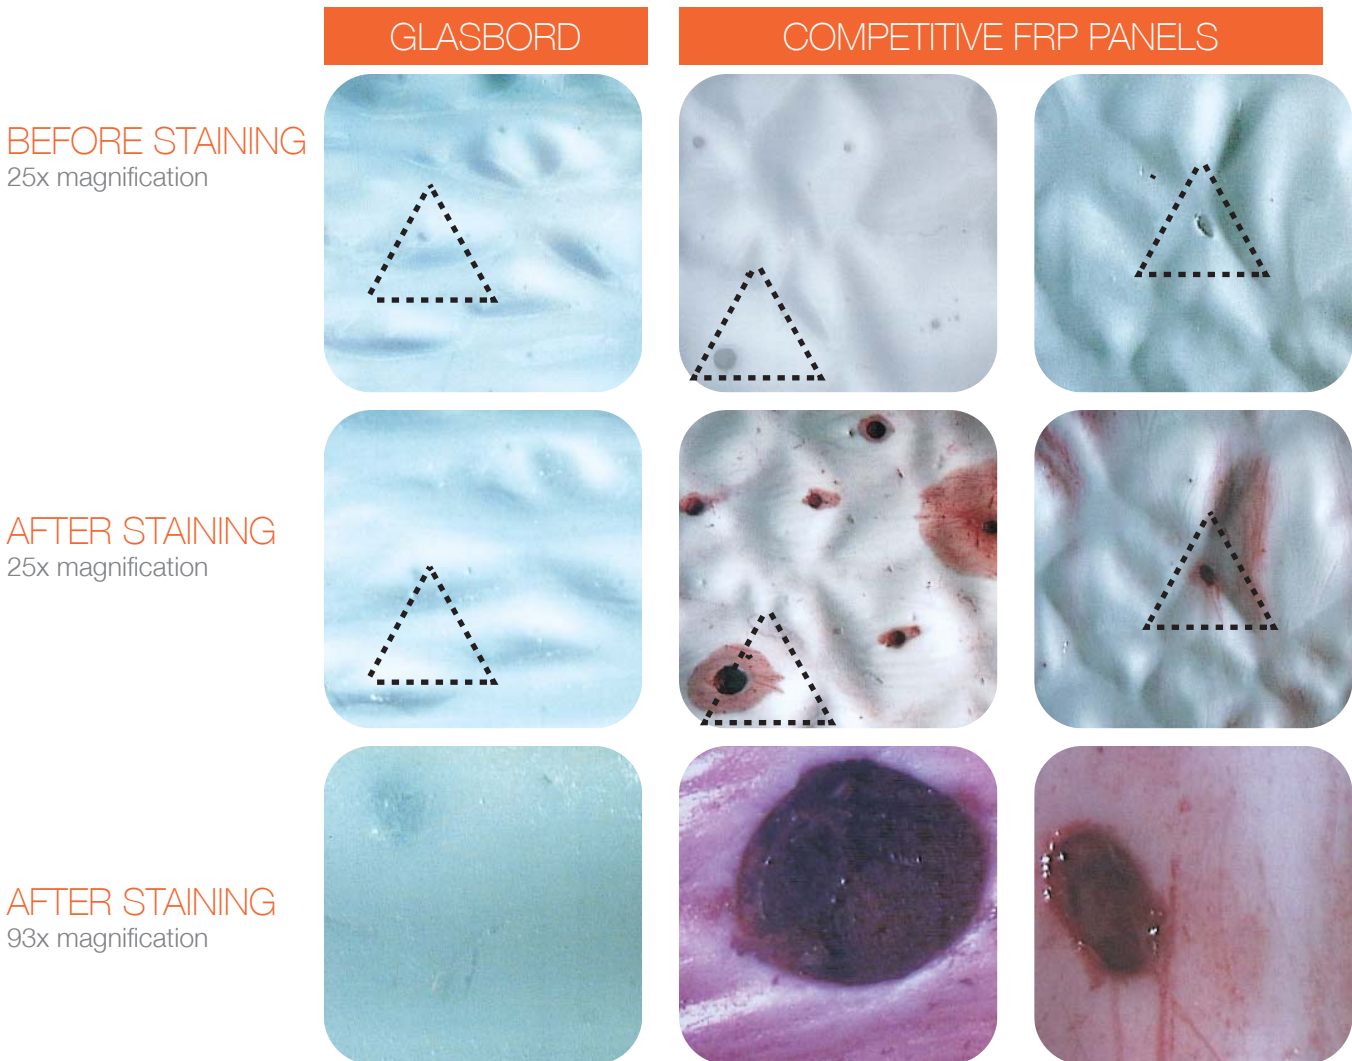
LABORATORY RESULTS

Inspection of the samples before abrasion shows open surface porosity on samples A, B, C, & D. Inspection of the samples after cleaning shows scratches on the surface of A, B, C, & D and additional open surface porosity. Penetrating dye has been absorbed by the scratches and surface porosity and was not removed by cleaning.

The Surfaseal finish on the Glasbord sample has sealed the surface and protected the panel during abrasion. No penetrating dye was absorbed by the panel.

"Competitive samples photographed in this test were received from customer inventories. These microphotographs represent the observed differences and apply only to the sample universe studied. Samples or products from magnified areas were chosen by Crane Composites lab technicians as representative of the entire surface."
