CRANE COMPOSITES, INC.

FMVSS and CMVSS 302 Flammability of Interior Materials Test

10/22/2019

2019-6349

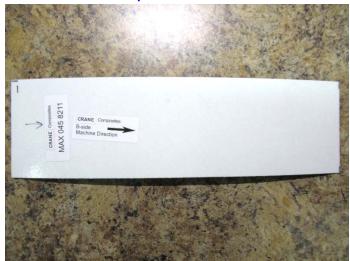
Typical Specimen (Back Side)

CCI MAX 045 8211 Specimens Oriented in the Machine Direction

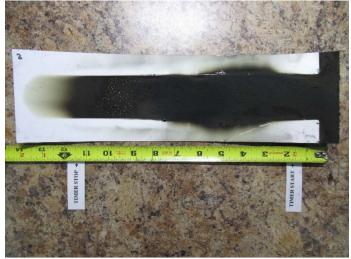
Sample 1 (Face Side/Exposed Side)

Sample Number	•		Comments / Observations		
1	10/22/2019	447.0 sec	10.0"	(254)	
2	10/22/2019	446.0 sec	10.0"	(254)	The specimens burned producing lots of dark gray
3	10/22/2019	553.0 sec	10.0"	(254)	smoke with no flaming drips.
	Average:	482.0 sec	10.0"	(254)

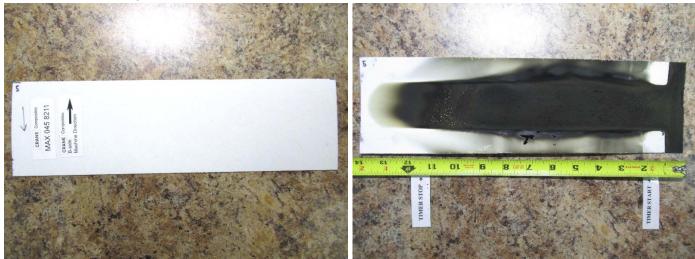
Typical Specimen (Back Side)

CCI MAX 045 8211 Specimens Oriented in the Cross-Machine Direction

Sample 5 (Face Side/Exposed Side)
